## Technical Service Information Bulletin

# EXCESSIVE ENGINE NOISE AFTER TRANSAXLE REMOVAL

'07 ES 350

ENGINE  
EG016-06

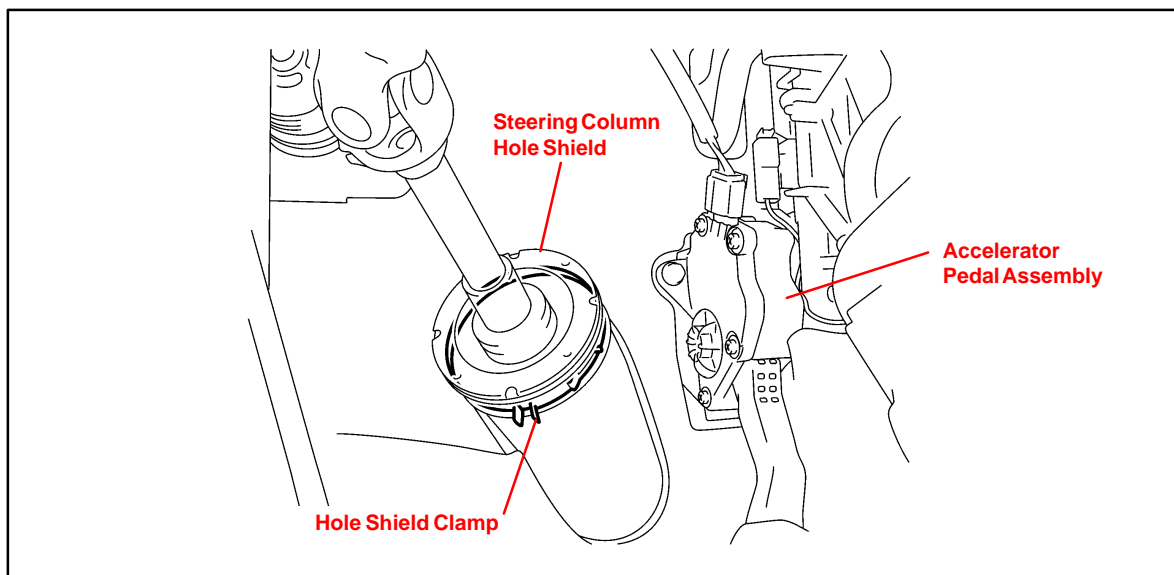
**Introduction** Some 2007 model year ES 350 vehicles may exhibit engine noise after the transaxle is removed and reinstalled. This noise may be caused by a dislodged steering column hole shield at the base of the steering column.

**Inspection Procedure** Inspect the steering column hole shield to ensure that it is properly seated and that the clamp is securely fastened.
